Manhole Inspection Summary

Manhole # S21GG_013MH

Location Address: **1700 BAKER ST**

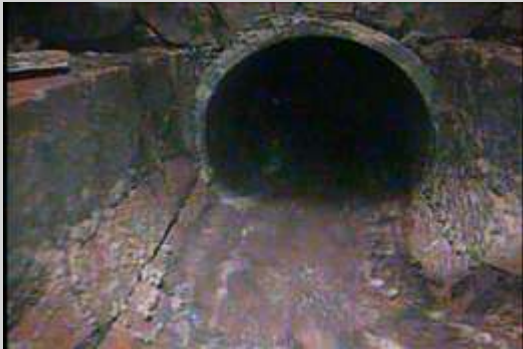
12 O'Clock Outflow

10 in. Circular Gravity Sewer
Pipe Out @ 12 O'Clock

Pipe Height: **10.8** (in.) Rod and Bar (Angled)
Pipe Material: **Clay** ☐ Pipe Lined
Invert Depth: **10.22** (ft.) Flow Characteristics: **Slow**
Deposits: ☒ None ☐ Mud ☐ Sludge ☐ Debris ☐ Grease
Silt Depth: (in.) Deposits Extent:
Infiltration: **None** Pipe Seal Cond: **Sound**

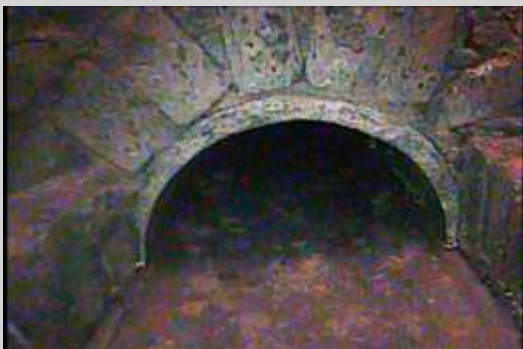
3 O'Clock Inflow

10 in. Circular Gravity Sewer
Pipe In @ 3 O'Clock

Pipe Height: **9.6** (in.) Rod and Bar (Angled)
Pipe Material: **Clay** ☐ Pipe Lined
Invert Depth: **9.93** (ft.) Flow Characteristics: **Slow**
Deposits: ☒ None ☐ Mud ☐ Sludge ☐ Debris ☐ Grease
Silt Depth: (in.) Deposits Extent:
Infiltration: **None** Pipe Seal Cond: **Sound**
